**Flood Control Project Maintenance
Levee Inspections**

Fall 2012 Levee Maintenance Deficiency Summary Report

Eastern Honcut Creek

Waterway	Bank	Unit Miles	Inspection Start/End	Inspector
Unit No. 01 Van Tress	Left	1.50	10/30/2012 10/30/2012	Clay Thomas

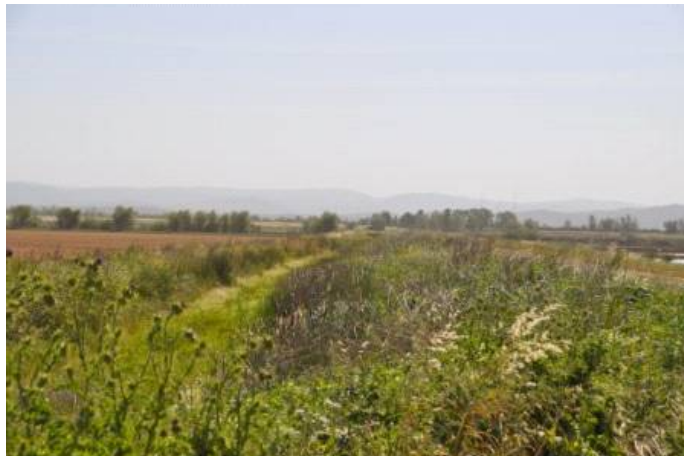
Levee Mile Report Line	7
Start Levee Mile	0.66
End Levee Mile	1.19
Location	Water Side
Category	Earthen Levee
Item	Encroachments

Toe Ditch parallel to levee @ w/s toe. Heavy vegetation in ditch.
